Manhole Inspection Summary

Manhole # S21MM_002MH

Insp Date: **7/2/07 8:37 AM**

Location Address: **2134 FULTON-MONROE**

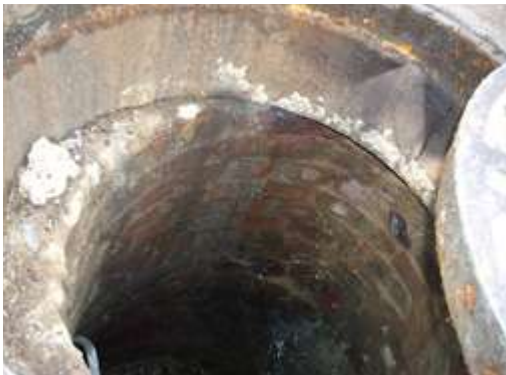
Defect 2

Infiltration: ☐ None ☐ Joint ☐ Cracks ☐ Mortar ☐ Roots ☒ Wall

INFILTRATION OF CORBEL

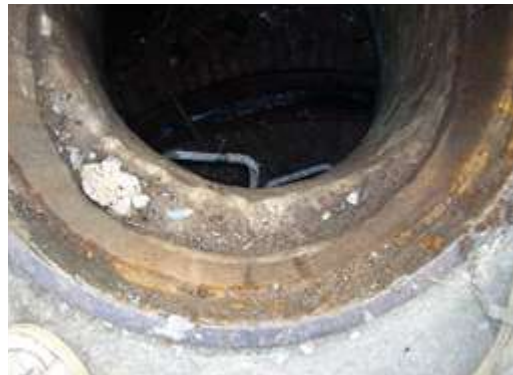
Defect 1

Frame Offset: **4** (in.) Condition: ☒ Sound ☐ Cracked ☐ Leaks

FRAME OFFSET

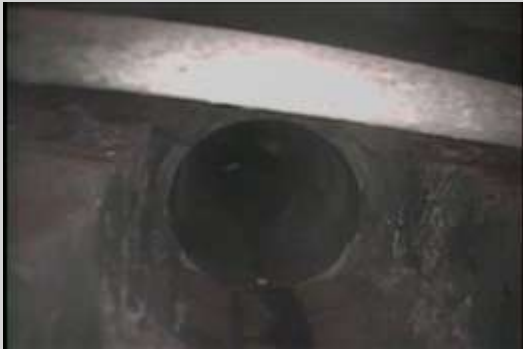
12 O'Clock Outflow

8 in. Circular Gravity Sewer
Pipe Out @ 12 O'Clock

Pipe Height: **8.4** (in.) Rod and Bar (Angled)
Pipe Material: **Clay** ☐ Pipe Lined
Invert Depth: **7.55** (ft.) Flow Characteristics: **Slow**
Deposits: ☒ None ☐ Mud ☐ Sludge ☐ Debris ☐ Grease
Silt Depth: (in.) Deposits Extent:
Infiltration: **None** Pipe Seal Cond: **Sound**
